Monitoring Data Record

Project Title: R-2214A COE Action ID: 200330312
 Stream Name: Mud Creek Tributary (Site 3) DWQ Number: 011715
 City, County and other Location Information: Intersection of US 25 and Industrial Park Rd. in Hendersonville, NC
 Date Construction Completed: March 2005 Monitoring Year: (4) of 5
 Ecoregion: _____ 8 digit HUC unit: 06010105
 USGS Quad Name and Coordinates: _____

Mud Creek Tributary

Year 4 Winter – March 2009

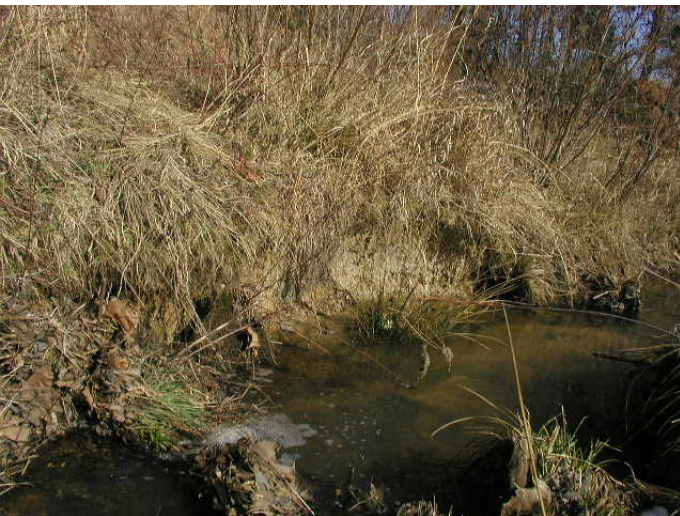
The stream is stabilized for the Year 4 Winter evaluation, except for some bank scouring noted along the left bank downstream of photo 6 @ Sta. 184+00. This area of bank scouring is where the small beaver dam was removed. NCDOT will continue to monitor this stream relocation.

Date Inspected 8/14/08	Station Number 184+00 (Downstream of Photo 6)	Station Number	Station Number	Station Number	Station Number
Structure Type					
Is water piping through or around structure?					
Head cut or down cut present?					
Bank or scour erosion present?	Bank scouring noted on left bank				
Other problems noted?

Bank scouring on left bank downstream of Photo 6
